LTE interference and CATV

ARCOM

July 2014

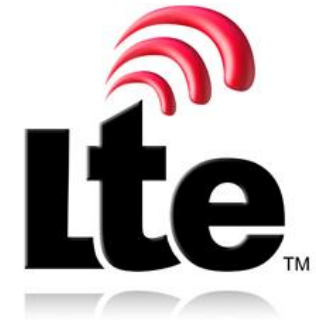
- LTE means (Long Term Evolution)
- 4G – 4th Generation
- Downlink: OFDMA - (QPSK, 16QAM and 64QAM)
- Uplink: SC-FDMA (QPSK and 16QAM)
- Paired Duplex: FDD (Frequency-division duplex) – paired downlink and uplink
- Bandwidth: 5 or 6MHz generally

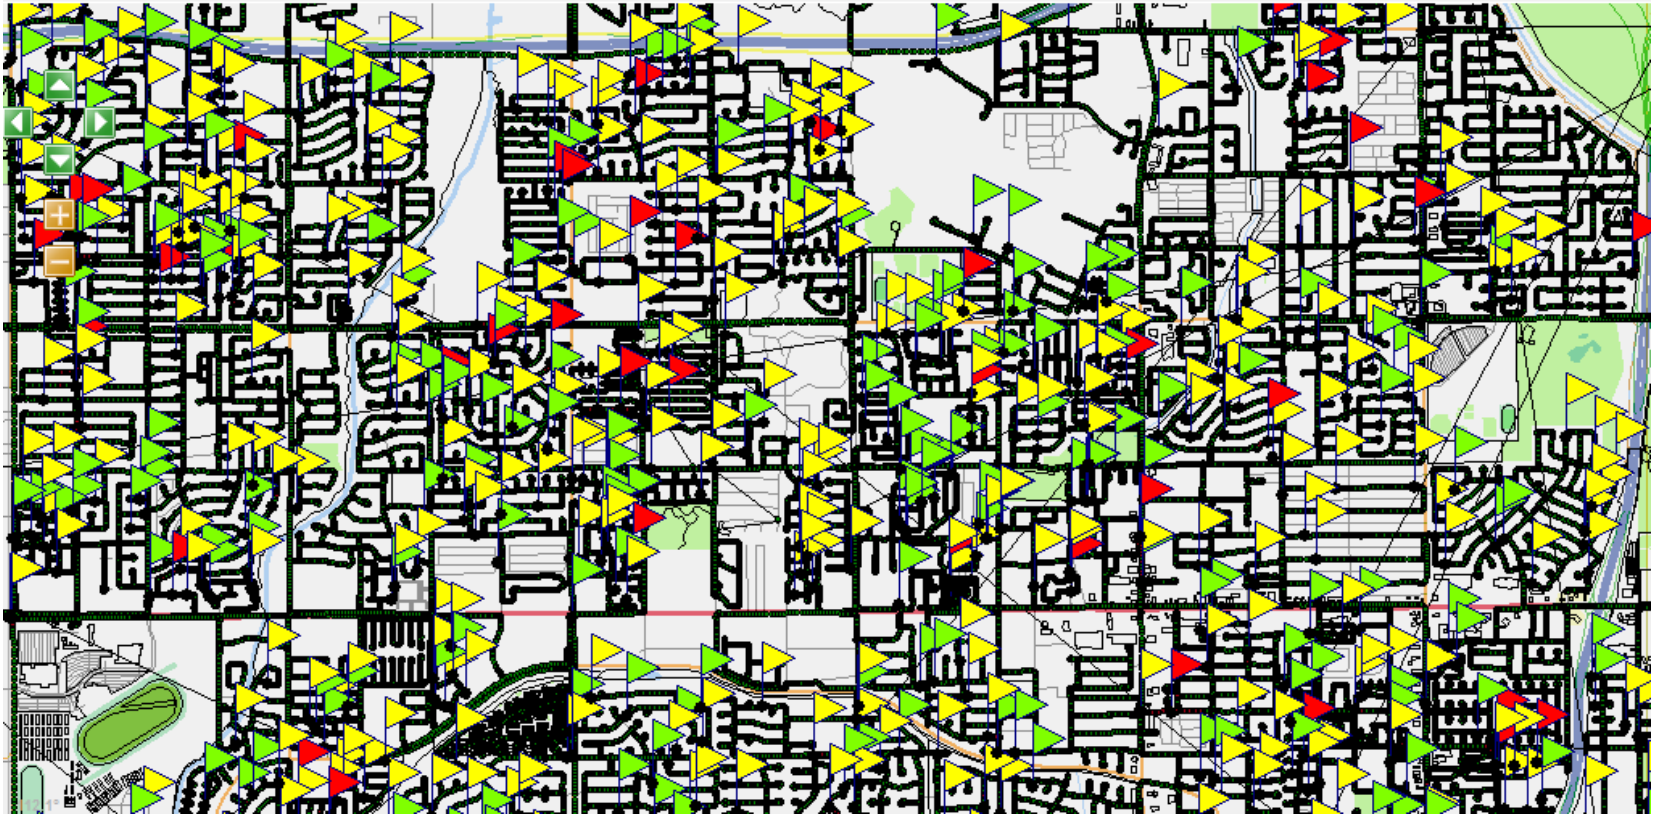
High frequency leakage measured at 717MHz.

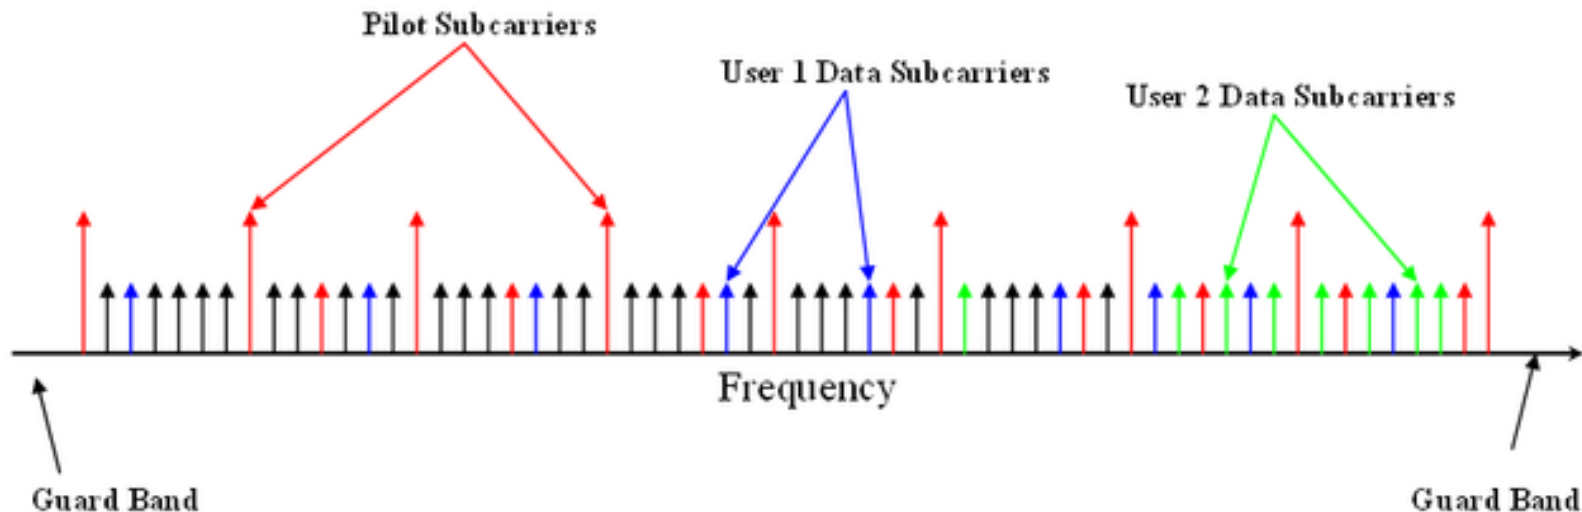
- LTE bandwidth is allocated in “Resource Blocks” allowing signal sharing by multiple users
- “Resource Blocks” are a set of subcarriers and OFDM symbols
- For a 10MHz signal there are 50 “Resource Blocks”. (5 per 1MHz)

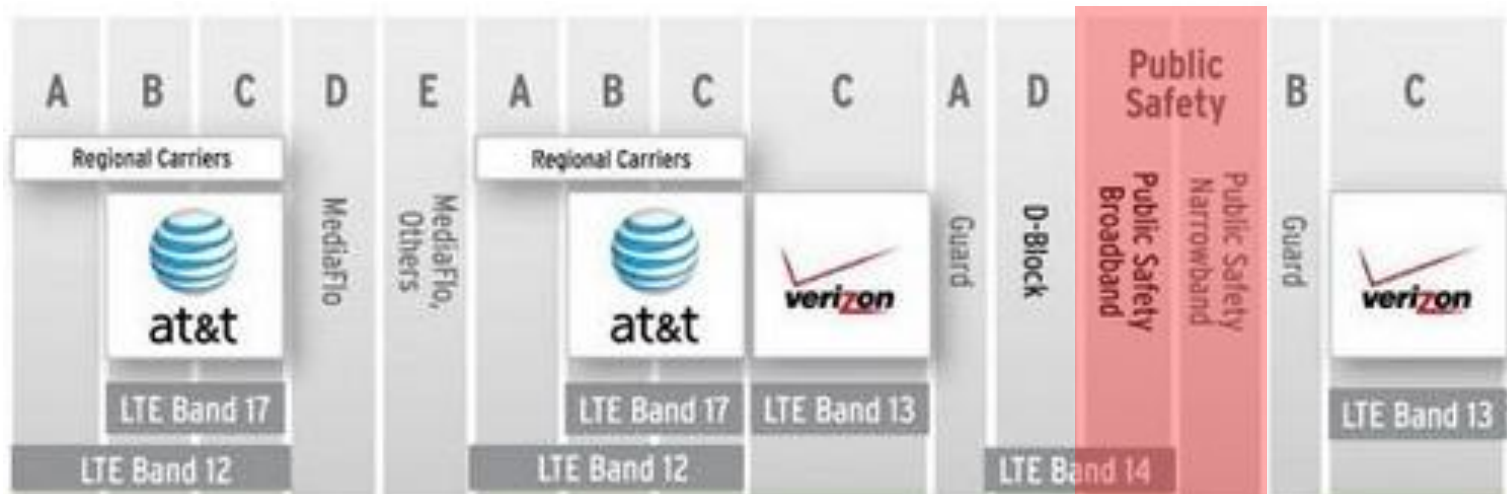
Frequency Allocation Example

- Frequency Allocations:
 - Band 13 (DL 746-756 MHz, UL 777-787 MHz) for Verizon
 - Band 17 (DL 734-746 MHz, UL 704-716 MHz) for AT&T.
 - Nationwide Public Safety (763-775, 793-805 MHz)

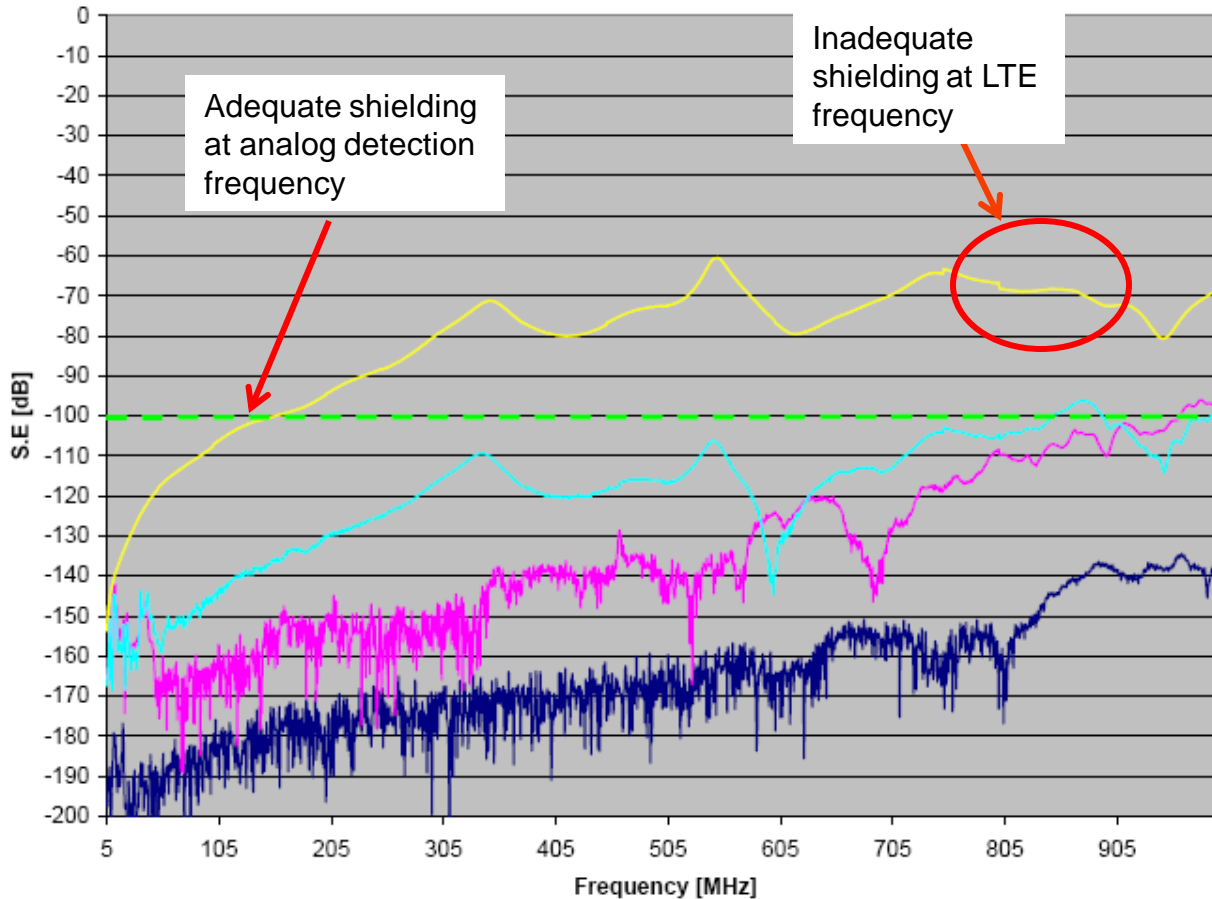
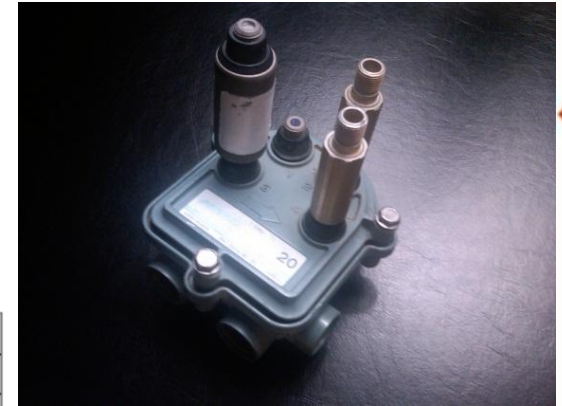
GTEM Tap Test, 7/6/2011

- Terminated Chamber
- Terminated reference tap (competing brand)
- Terminated leaking tap (in field condition)
- Terminated leaking tap (with new RFI braid)

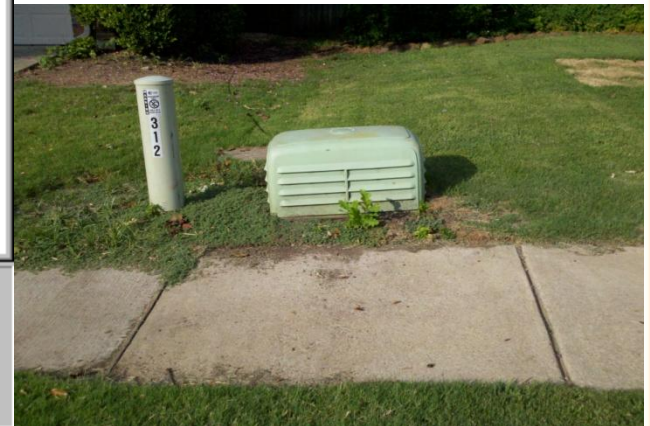
Here the measurement was made at a distance of ≈ 10 ft with an 11dBi Yagi at 780 MHz. The signal level at the top of the QAM at the input of the SA is ≈ -25 dBmV for the 30kHz ResBW. The field strength calculation at 10 ft comes out to a substantial **2200 μ V/m**.

Finding:
This CATV interference is coming from:
The Treehouse Apartments
3207 Walnut Hill Ln.

GPS Coordination:
3x.86586 -9x.98910

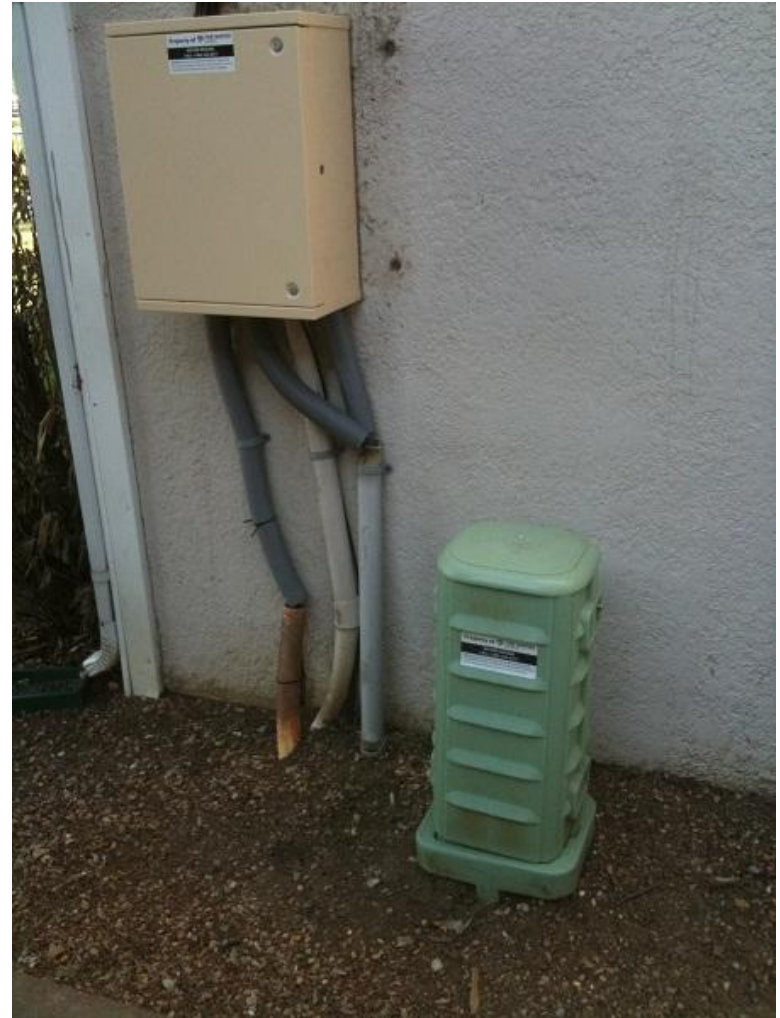
Finding:

GPS Coordinance:

3x.86615 -9x.98810

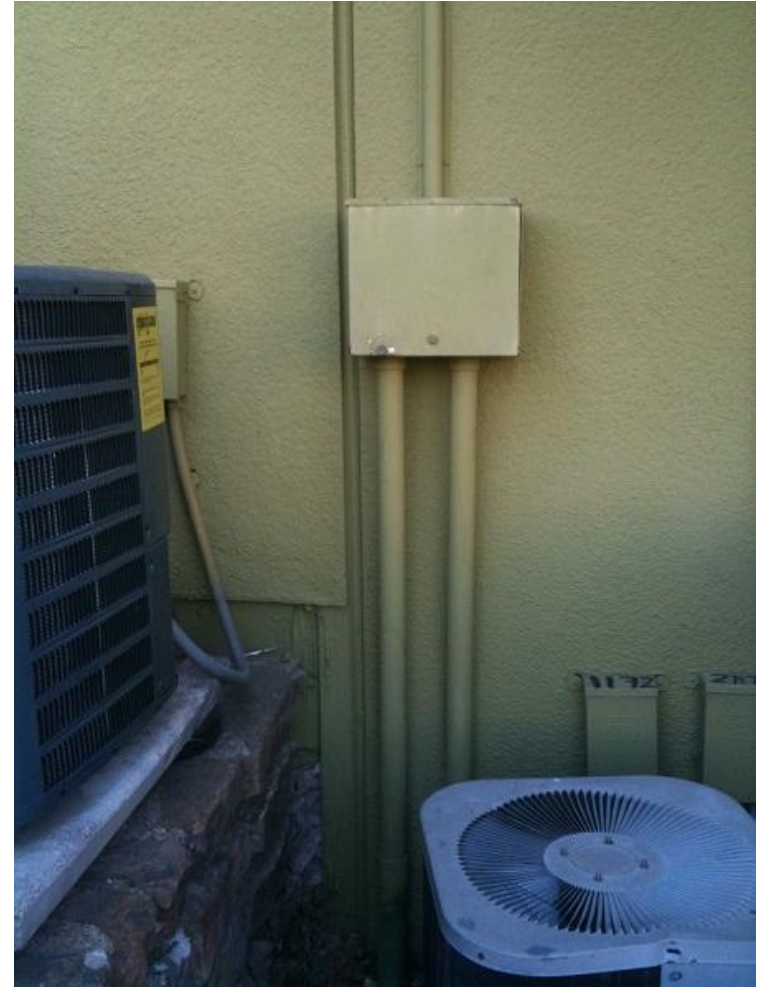
Finding:
This CATV interference is coming
from a pole by the tennis courts at:
Hillcrest Apartments
3101 Walnut Hill Ln.

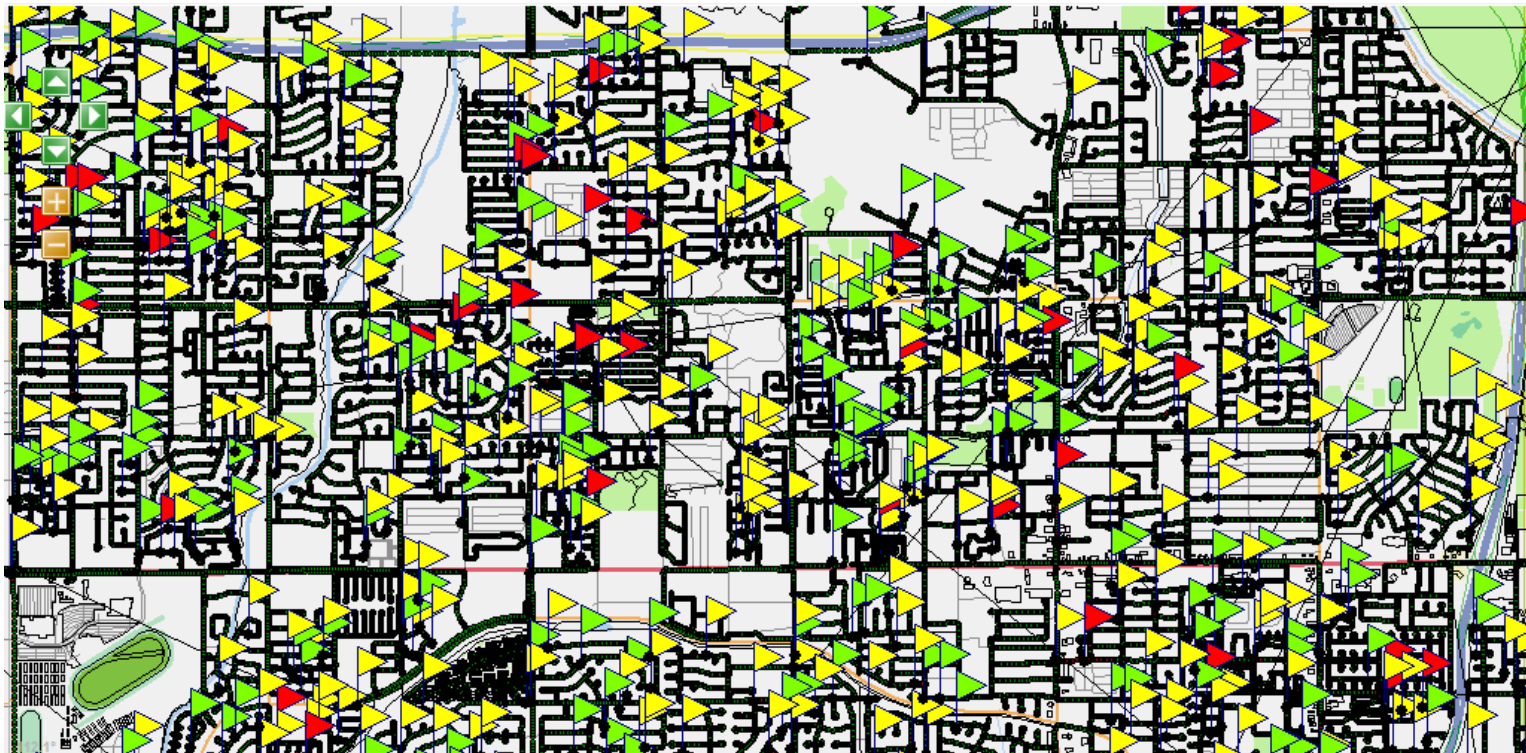
High Frequency Leakage – 717MHz

Red Flags are leaks $>100\mu\text{V}/\text{m}$, Yellow $20\text{-}100\mu\text{V}/\text{m}$, Green $<20\mu\text{V}/\text{m}$

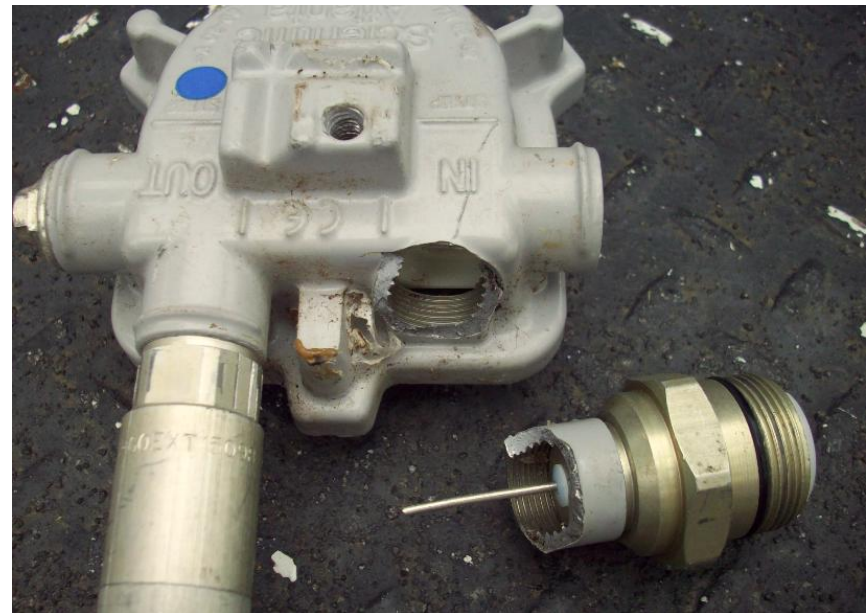
Flag 89 – 158uV/m – 5868 Beachwalk Dr

At Flag 89 was found a cracked tap housing

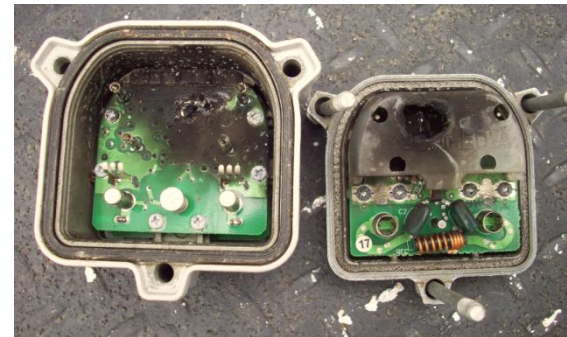
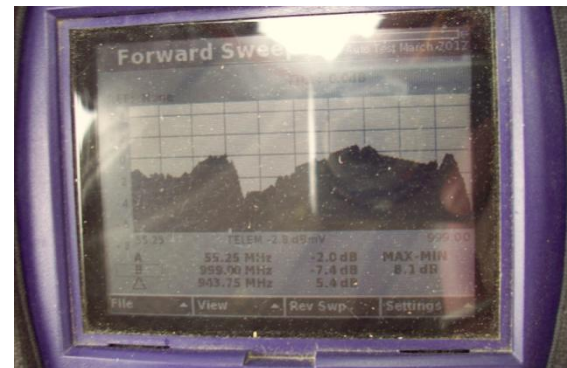
Flag 86 – 100uV/m – 5876 Goolagong Dr

Burnt out tap with suck out around 470MHz..

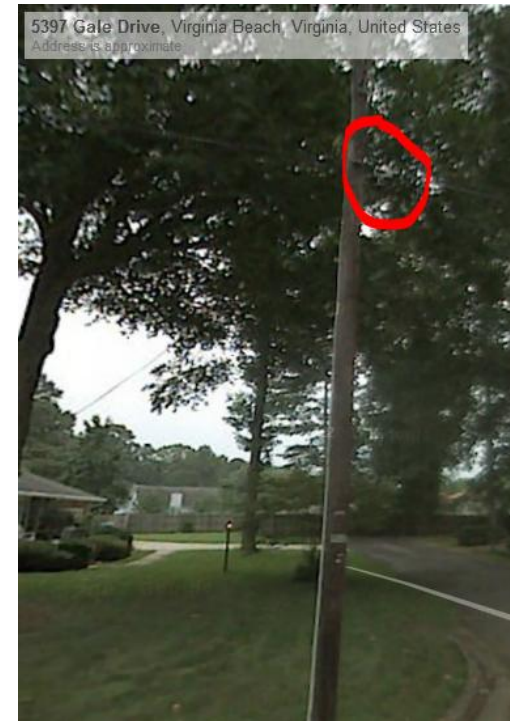
Flag 111 – 200uV/m – 5397 Gale Dr

At this location the tap was missing a screw in the tap plate. This is a good example of Time Difference of Arrival technology for calculating the GPS coordinates of a leak. TDOA puts the flag at the exact location of the leak.

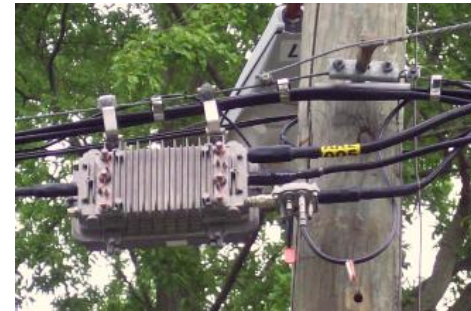
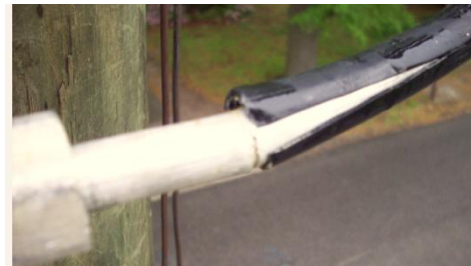
Flag 53 – 224uV/m – 5902 Woodstock Ct

Radial crack on the feeder cable.

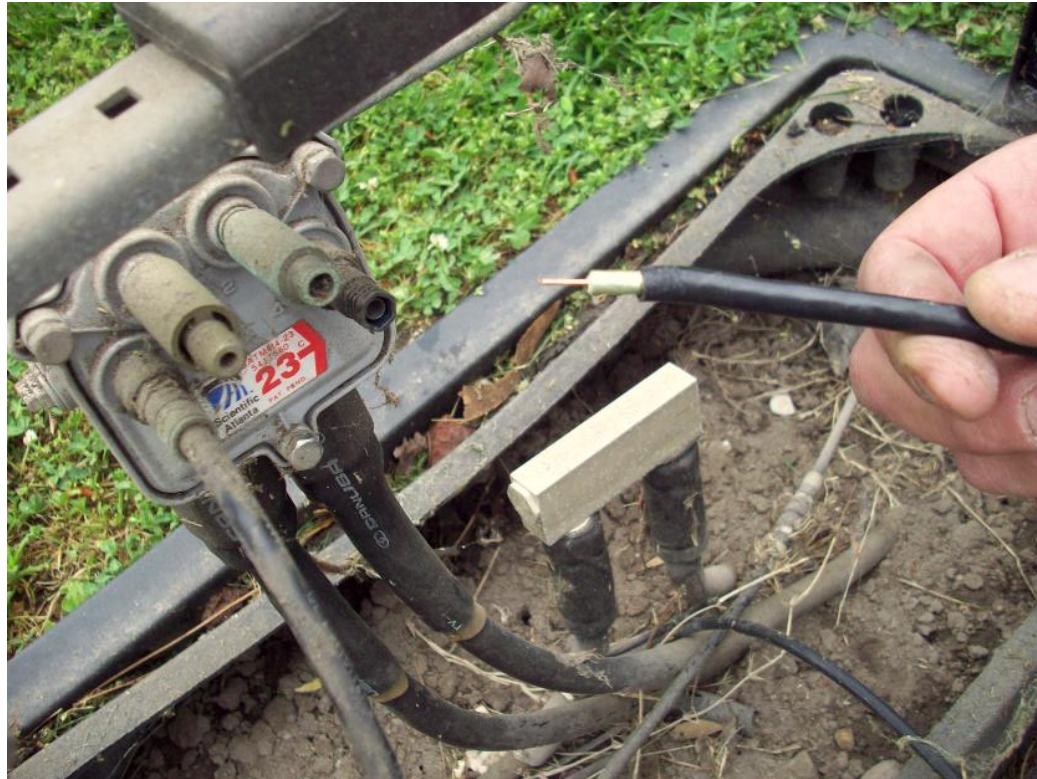
Flag 80 – 224uV/m – 5878 Clear Springs Rd

Drop cable had crimp on connector. Pulled drop cable out of the connector. This dropped the leak down in level but a smaller leak was still detected. The tap screws were also loose.

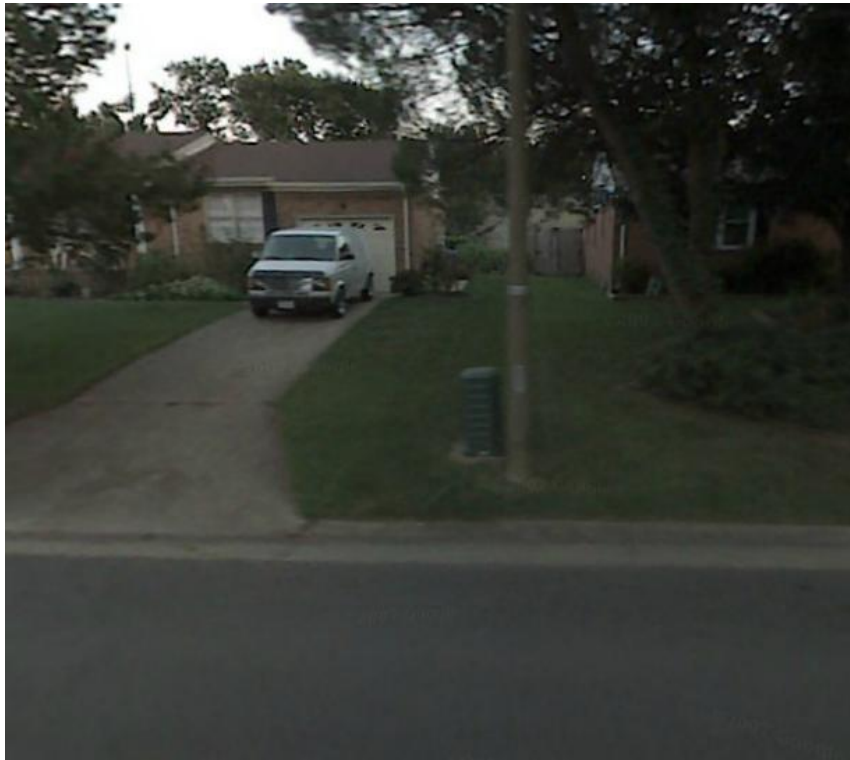
Flag 77 – 20uV/m – 5916 Cedar Springs Rd

At this amplifier, the source of the leak was not identified immediately. The night crew went back that evening, dug up the hardline and found damage 6 feet from the amp.

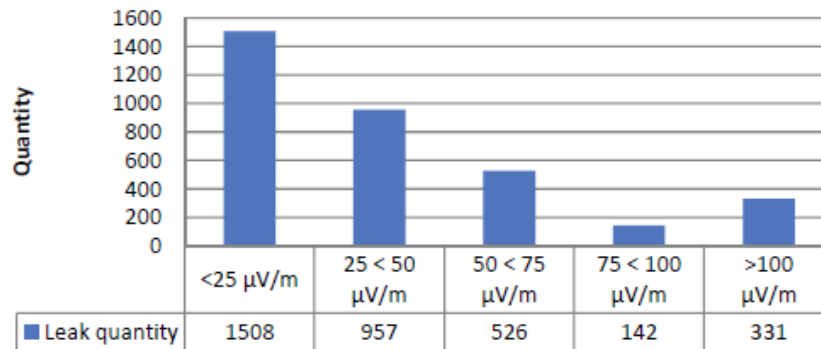
Quantity of leaks grouped by 10 ft. scaled level - 3,464 detected leaks

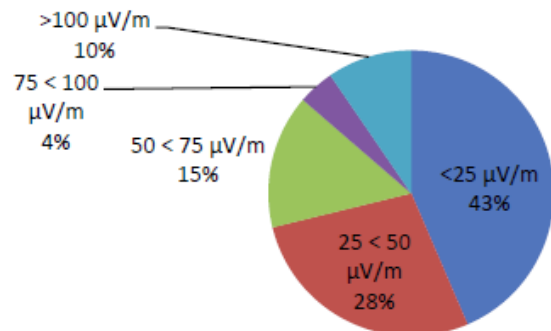
Leak level - total of 3,464 leaks

Average 1 leak per mile.

In 1000 mile plant there will most likely be 100 leaks over 100uV/m.

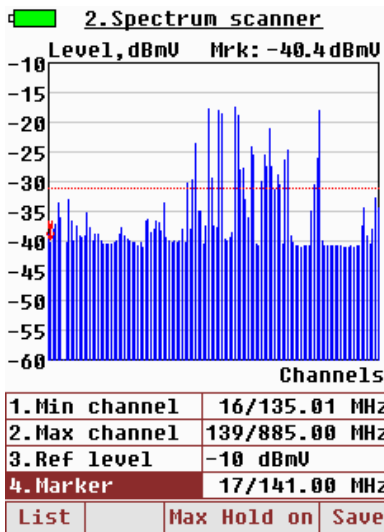
Taken with a high frequency antenna. Shows amount of terrestrial noise that could be a source of downstream ingress.

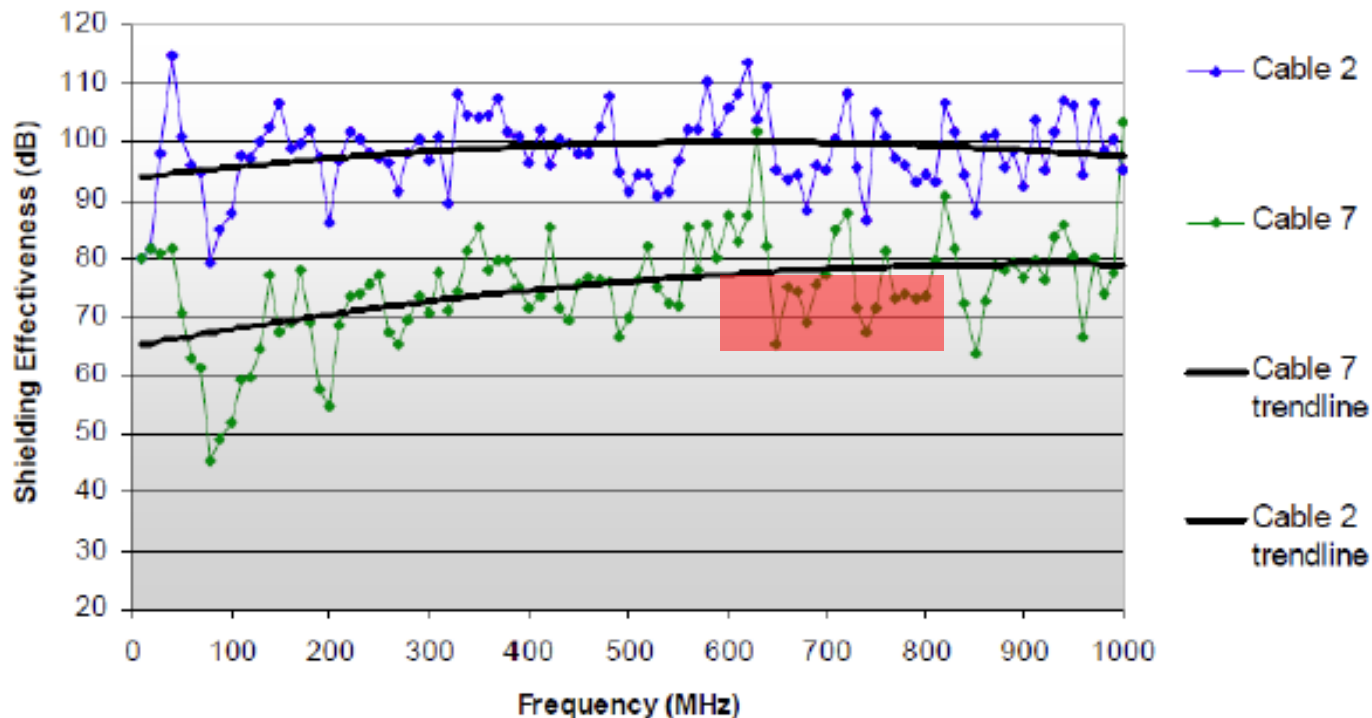
Trend lines of shielding effectiveness showing best and worst coaxial cables tested. Best cable shows 95-100dB of shielding while worst case only has 65-80dB of shielding. Will need test equipment that can measure less than 1uV/m leaks in order to find cable with poor shielding.

(Worst case is consumer grade cable with screw on F connectors)

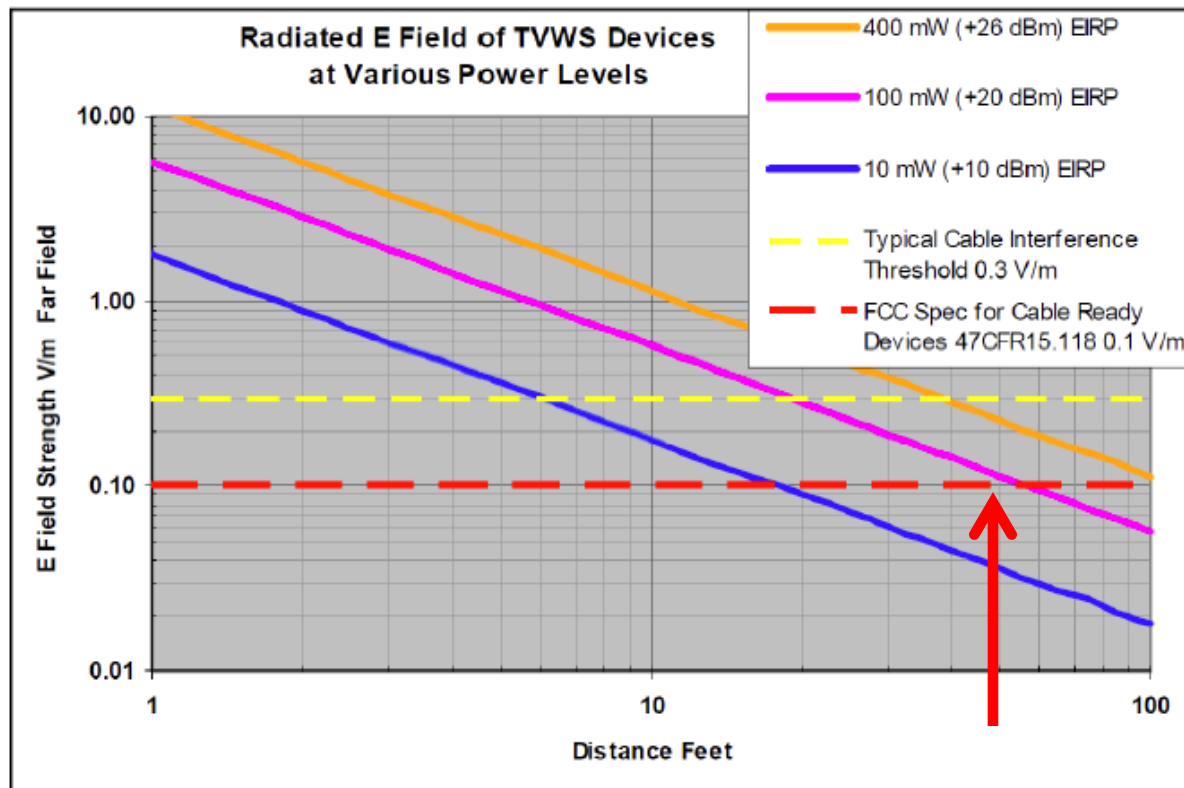
Current FCC requirement for Cable Ready Devices defines the threshold for field strength of interfering signal as 0.1 V/m. In the example above, a Smartphone with a 100mW output would need to be 57 feet away from cable device to not cause interference. Not possible within a home environment.

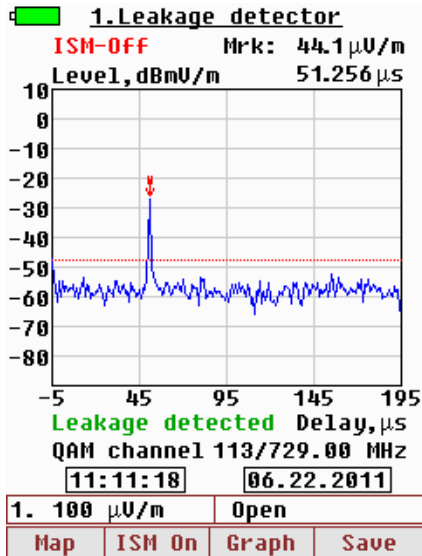
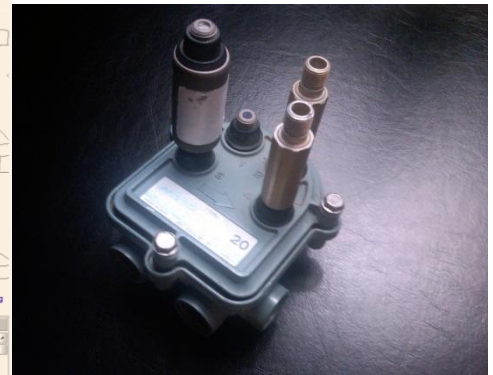
Detected a 112uV/m QAM leak at tap but analog leakage equipment didn't detect any leak. Operator said this is where Verizon was complaining of LTE interference. Asked operator not to take tap apart but give it to Arcom for testing. We re-spliced a new tap and resolved the impairment.

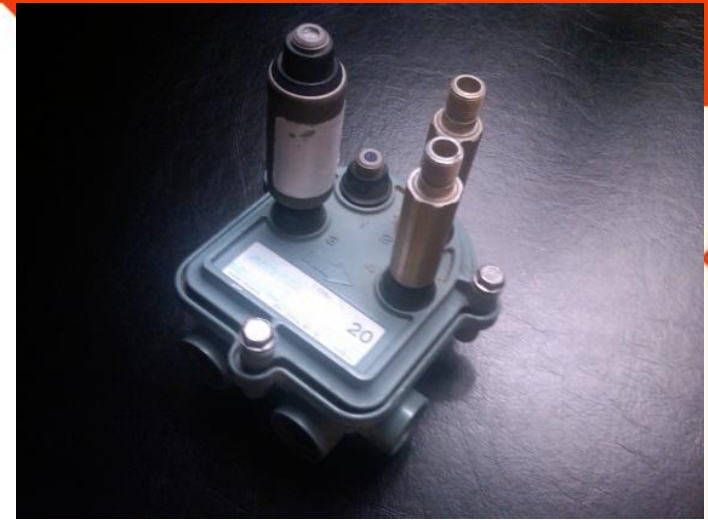
In our lab, the tap was tested using a GTEM in our lab, (precision electromagnetic emissions test equipment).

After testing the tap, was found that the RFI braid around the seal was bad. The results are show on the next page.

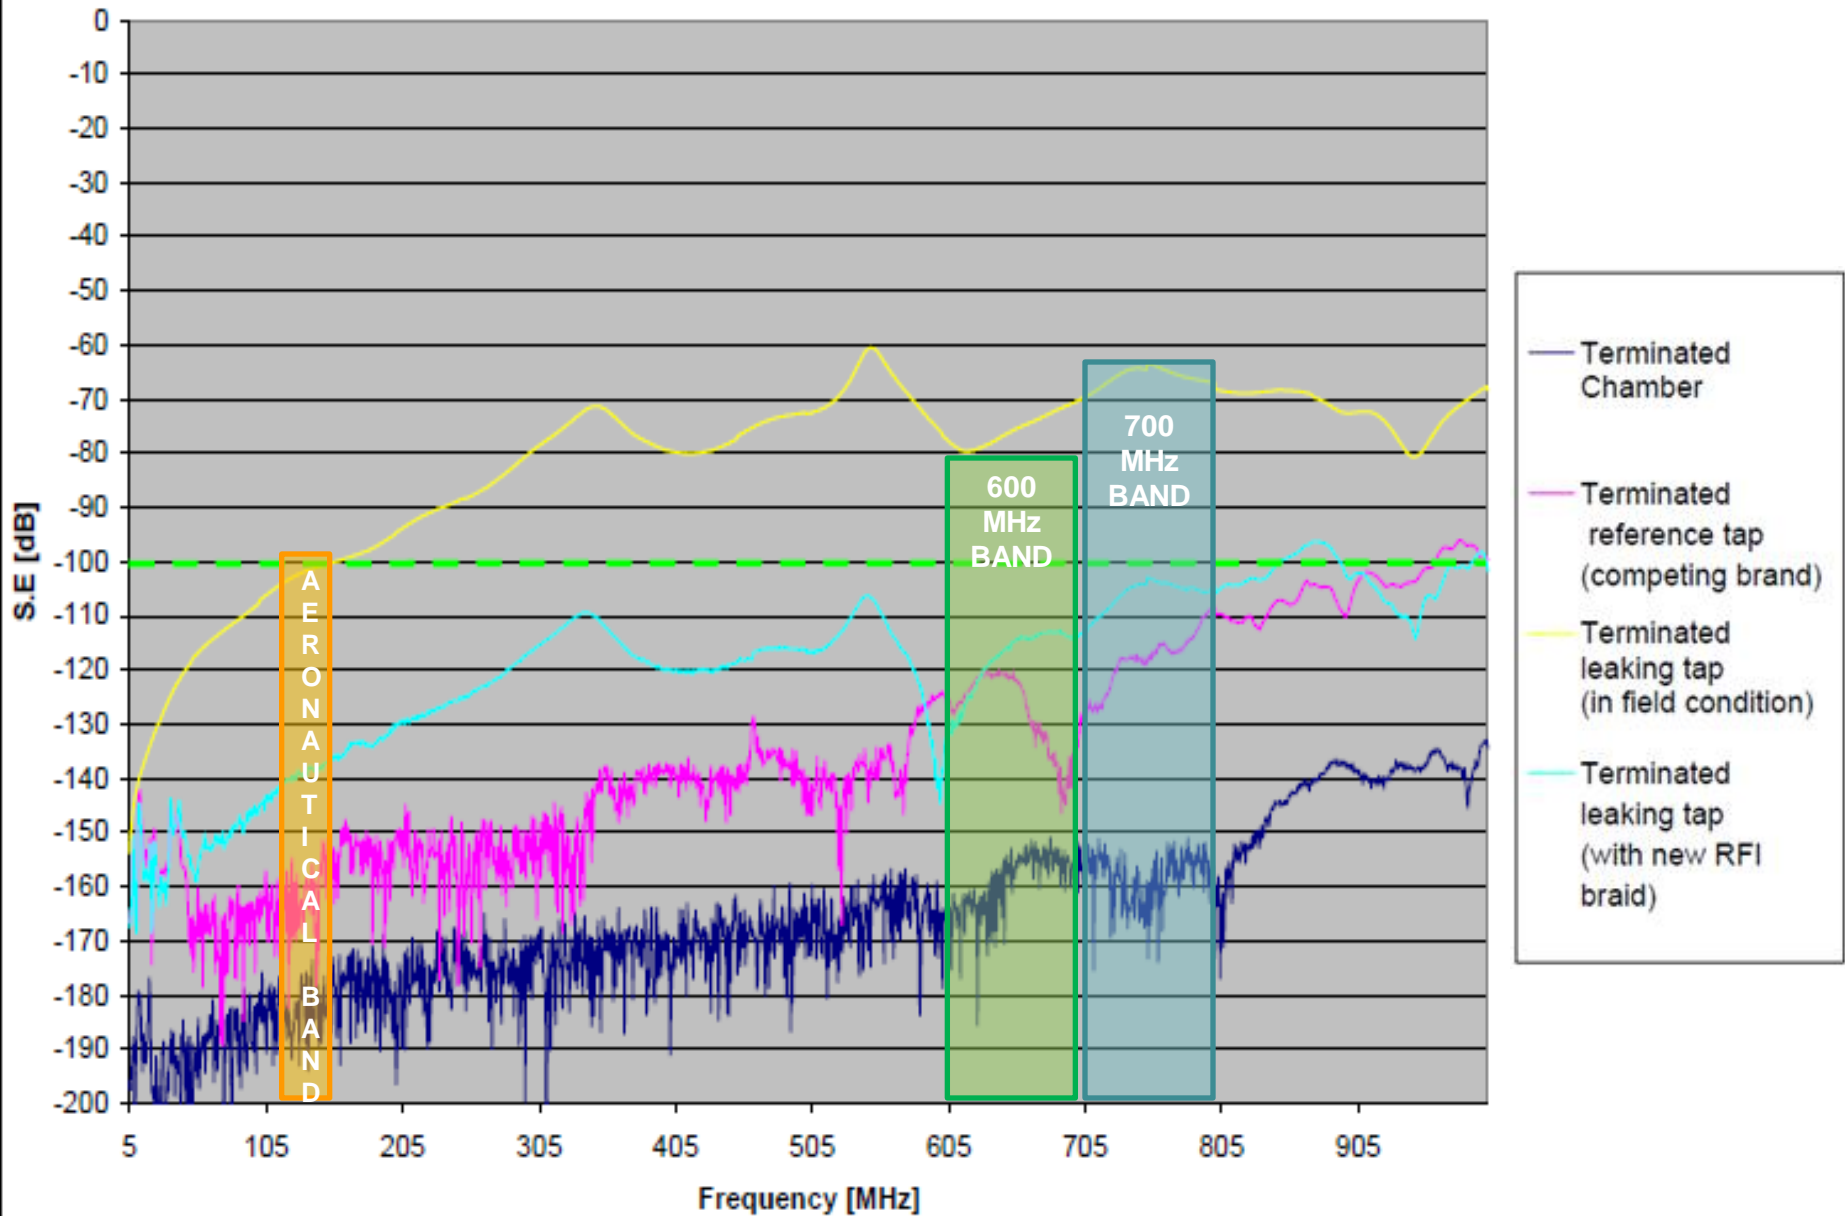
GTEM Tap Test, 7/6/2011

Note that at lower frequencies, below 150mHz, the RFI passes the -100dB standard. This is why traditional leakage equipment set in the aeronautical band wouldn't alarm. Was compared the original test with changing the braid and there was an improvement. Finally, was compared a different tap that we had in our labs.

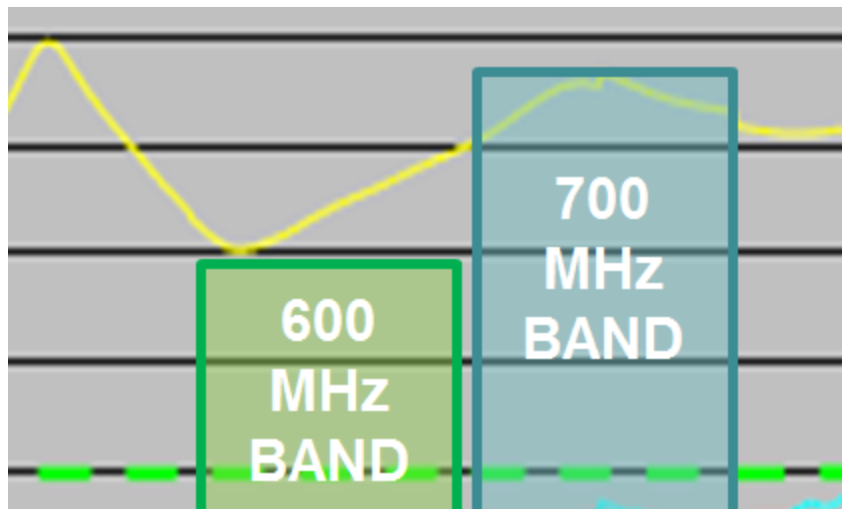
This tap was leaking at 112uV/m at 729MHz. With an 18dB difference between 605MHz and 729MHz, the leak only measured 14uV/m at 605MHz.

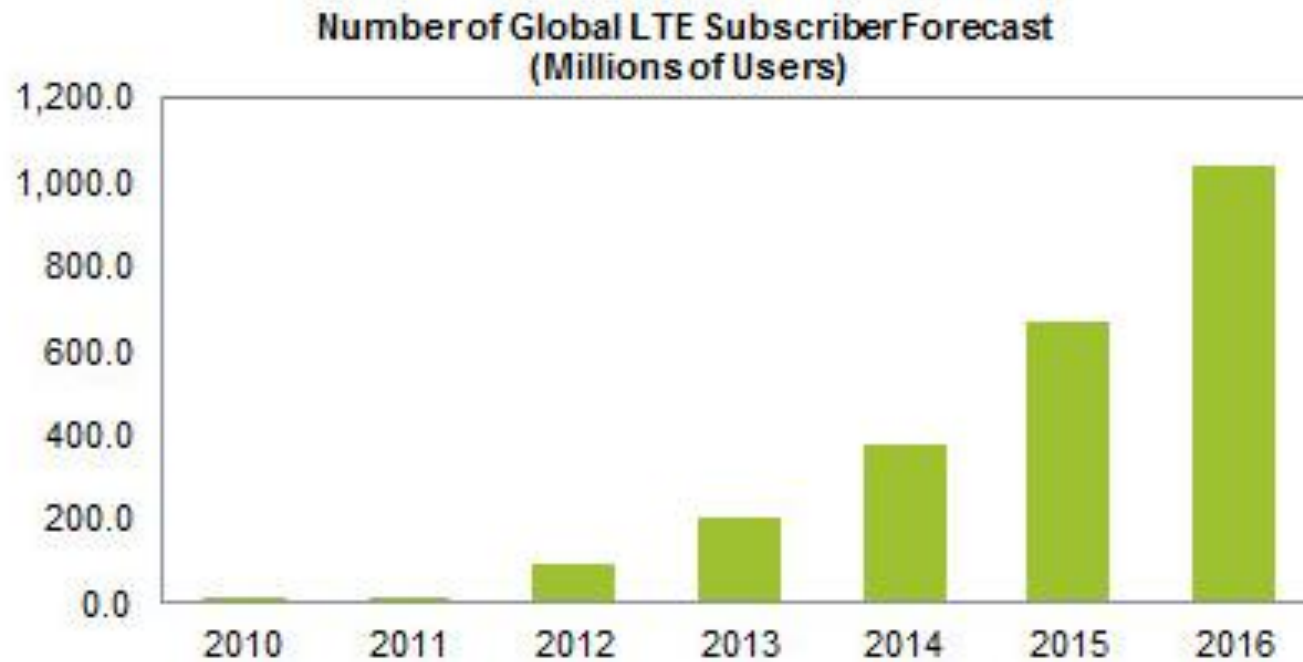
Mobile Data Growth

Source: IHS iSuppli Research, January 2013

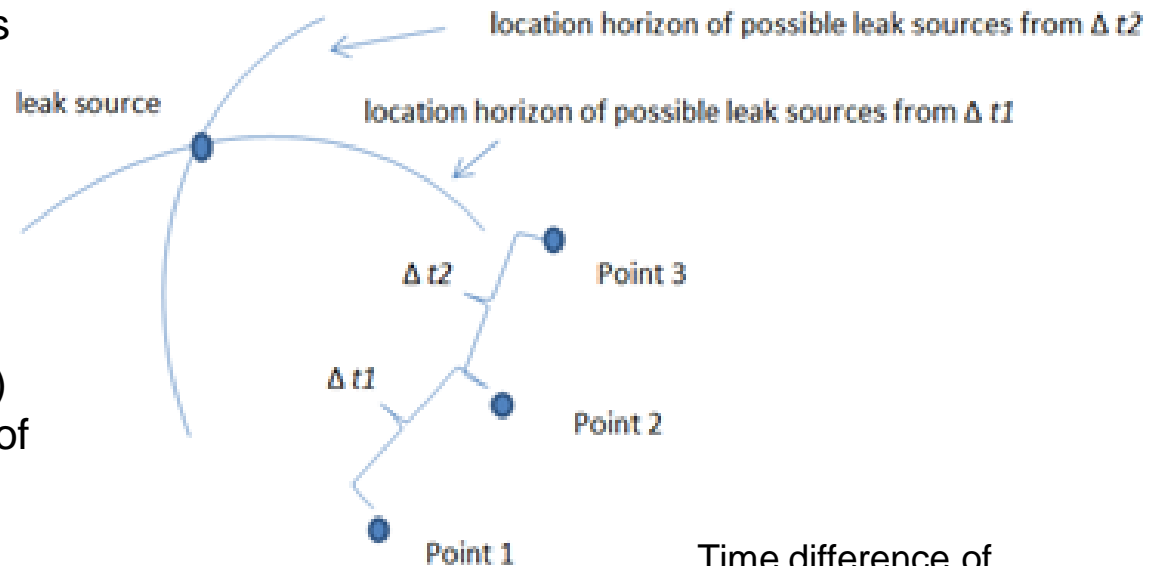
Because of the employed correlation detection process and inherent time delay output – we have a unique opportunity to make use of this data and employ the most accurate location methodology called Time Difference of Arrival (TDOA) to resolve the GPS location of the leak.

Time difference of arrival (TDOA) – hyperbolic location

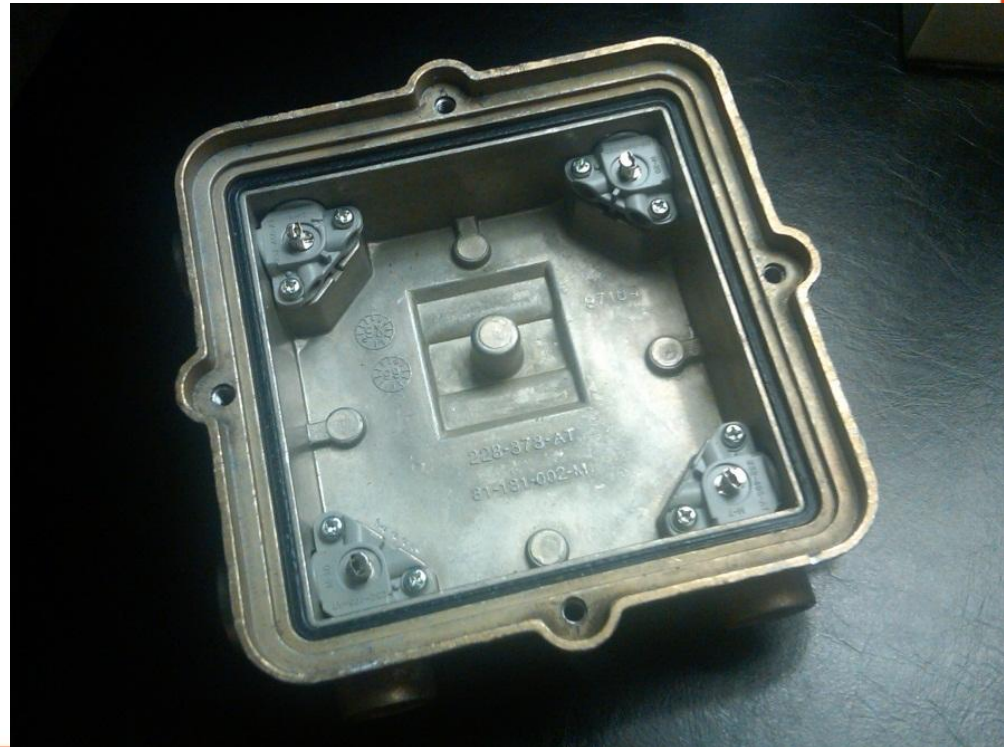
2nd example of QAM leak with no corresponding analog leak

This location corresponds to the area where the cable operator received a complaint of LTE interference. Truck roll 1 – operator went to the location with analog equipment and detected nothing. Truck roll 2 – operator revisited the location with spectrum analyzer and detected nothing. Truck roll 3 – digital leakage was detected utilizing the new technology we are discussing.
